Safety Screening Report

Report: 071-75924520-003 **Date:** 09/01/2014

Product: Electrical Accessory **ESC Sample Number:** 3

Summary: TÜV SÜD Product Service was commissioned by The Electrical Safety Council to evaluate an Electrical Accessory (see figure 1). The aim of the assessment is to assess the product against the clients Safety Screening Test Plan.

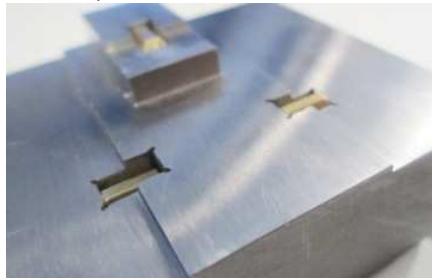
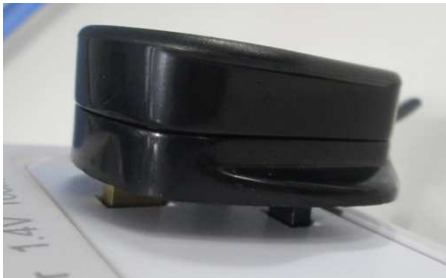
**Terminals & Terminations
(BS 5733, Clause 14)**

Constructional Quality	<input type="checkbox"/> -Pass <input checked="" type="checkbox"/> -Fail
Comments	<p>The product was supplied with a Scolmore branded, class I, BS1363 marked plug. The license number was verified online; however the quality of the materials used and lack of markings (part reference) were not considered to be of that usually seen by the brand. A check within a calibrated BS 1363 plug gauge revealed that the live pin was too short. Some lateral movement of the live pin was also observed. A check revealed that it was also difficult to insert / remove a number of BS 1363 approved plugs into the sockets. It was noted that the earth pin did not always fully engage before the live / neutral pins.</p> <div style="display: flex; justify-content: space-around;">

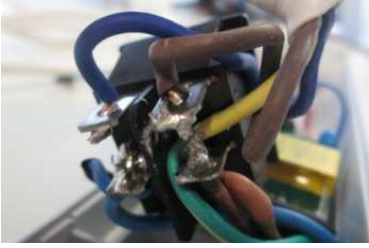
</div> <p>The supply cords earthing conductor was found to be weaved through the switch's terminals which were not sleeved as expected. It was found that the sharp edges of the live connection had caused some damage to the sleeving.</p>

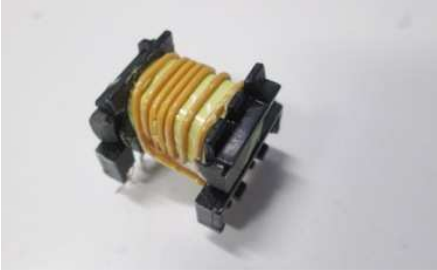
Creepage Distances, Clearances & Distances Through Insulation (BS EN 61558-1, Clause 26)	
Constructional Quality	<input checked="" type="checkbox"/> -Pass <input type="checkbox"/> -Fail
Comments	<p>A minimum creepage / clearance distance of 4.8mm was measured between the primary and secondary side of the circuit. The standard requires a minimum of 5.0mm; it was therefore considered to be on the limit. Better quality control would ensure this does not happen.</p> <p>The transformer was constructed with a triple-insulated secondary winding; therefore considered to provide an adequate barrier from the primary side.</p>

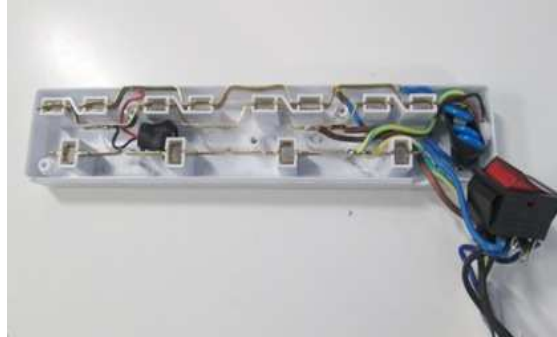
Internal overview (13A Sockets)

<p>The connections within the internal socket assembly were found to be either soldered or welded. It was found that that the quality of both methods of connection was inadequate.</p>

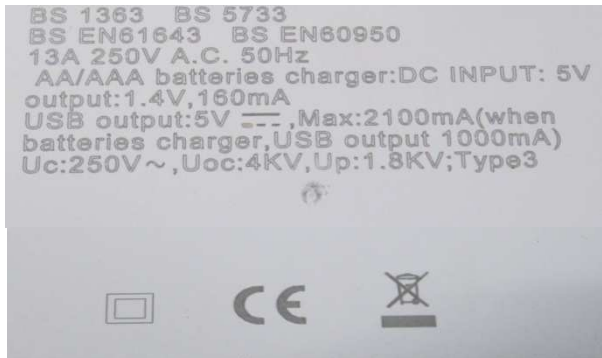
Markings

Findings			
Markings/Warnings (BS 5733, Clause 8)			
Marking of Product	<input checked="" type="checkbox"/> -Inadequate <input type="checkbox"/> -Poor <input type="checkbox"/> -Adequate <input type="checkbox"/> -Good <input type="checkbox"/> -Very Good <input type="checkbox"/> -N/A		
Comments	<p>The product was adequately marked with all of the required information. This included the model reference, input rating, output ratings (covering each of the outputs), distributor trademark, CE marking and WEEE logo. The relevant standards were stated; however BS 5733 should be marked as BS 5733/A as it is a portable product.</p> <p>The product was supplied in an unmarked, plain white cardboard box with no instructional information. It is expected that guidance regarding general safety, operation and compatibility would be provided; however this was not supplied for the end user.</p>		
Rating Plate/Photo	<input checked="" type="checkbox"/> -Yes <input type="checkbox"/> -No <i>If yes see last page of report</i>	CE Marking	<input checked="" type="checkbox"/> -Yes <input type="checkbox"/> -No

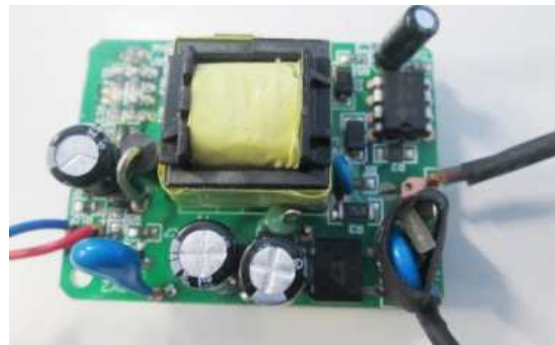
Control PCB

Comments	<p>A fusible resistor was fitted to the primary side of the control circuit. Thermal protection devices were also found on the control circuit (x1) surge protection circuit (x2); however these did not carry any verifiable approvals markings.</p>
Mechanical Strength (BS 5733, Clause 21)	
Result	<input checked="" type="checkbox"/> -Pass <input type="checkbox"/> -Fail
Comments	<p>The product was subjected to an impact test. This was carried out with the free end of the cable held against a wall with the cable held horizontally at 400mm above a hard floor then allowed to drop. This was repeated with the cord rotated through 45° at its fixing eight times. No damage was observed.</p>
